APEK GUIDANCE NOTE	ACCEPTANCE OF NON-CONFORMING WELD ROOT OVERLAP, REINFORCEMENT, SPATTER IN CS PE	APEK GN 234 Rev: 1 17/10/2017
-----------------------	--	-------------------------------------

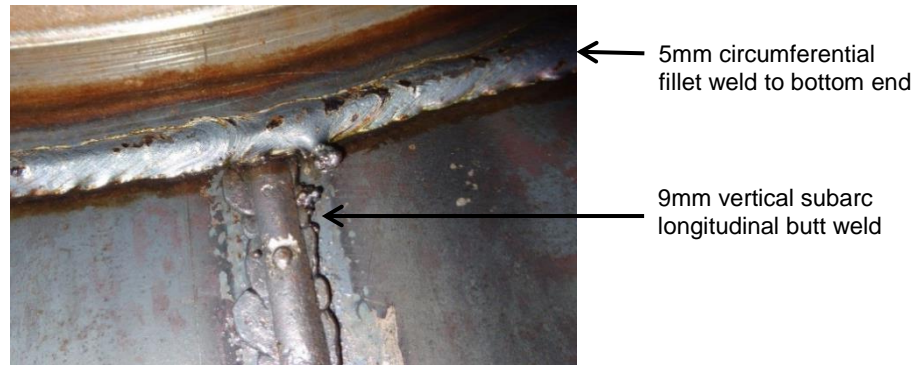
Fig 1 Internal View
(4 types of flaw)

- 4 Signs** **Root reinforcement:** 2.5mm continuous; **root overlap:** 2mm – continuous on both sides;
(Indications) minor **spatter** from circumferential weld; and weld **oxide scale**

- 5 Sign location** Inside vessel on vertical longitudinal weld.
- 6 Detection** By IS Inspector during commissioning inspection in Australia by VT in 2014

- 7 Assessment** .1 The inspector sought competent advice on flaw identification etc, and which Standard applied.
(by inspector, .2 Check with 100% UT showed no other flaws. Various Standards were reviewed.
adviser and .3 **Overlap** did not conform (DNC) with AS 4037, but was acceptable in ASME VIII-1
owner-user) UW35a).
Overlap is equivalent to a joint joggled or with backing strip - both allowed for circumferential joints.
Overlap (and **spatter** and oxide **scale**) might not be acceptable for severe corrosion service or where hygiene is critical as with food or medical PE.
.4 For this Service conditions: Corrosion negligible with oil – very low risk of corrosion failure.
Low stress (effective safety factor = $3.5/(\eta=70\%) = 5.0$; low stress range, medium no. of cycles and "crack" parallel to stress. Hence very low risk of fatigue failure.
Spatter and thin **oxide scale** acceptable.
.5 **Weld root reinforcement** of 2.5 mm complies with AS 4037, is within 0.1mm with ASME VIII-1. It might not be acceptable for flow-accelerated corrosion or complete drainage

- 10 **Probable cause(s)** Poor fitting backing bar (eg copper) for small diameter vessel
- 11 **Outcome** Put into service without removal or repair because:

- 12 **Fix** No correction was required.
- 13 **Prevention** In manufacture: better shaped backing bar, edge bending or clamping; better QA or inspection.
In service: after 10 to 15 years, spot UT of the vertical weld lower half might be desirable
